**Fire Risk Assessment  
South Liverpool Homes  
21-23a Harefield Road  
Speke  
Liverpool  
L24 0SA**

| Report Reference: | N-330573 |
| Issue Date: | March 2026 |

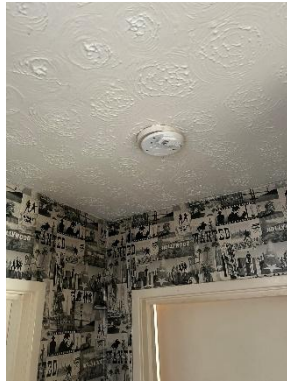
| Task | | | |
|---|---|---|--|
| Significant findings | The assessor identified flat 23A currently did not have any detection within their flat as the one in the hallway had been taken down.<br><br>Please note - Flat 23A has identified asbestos textured coating to the ceiling of the hallway. This appears to be in good condition, however a risk assessment for disturbance of the ACM should be undertaken before any works are to be carried out. | | |

| Task | | | |
|---|---|---|--|
| Actions required | Reinstall detection for the tenant in flat 23A. | | |
