**Fire Risk Assessment  
South Liverpool Homes  
Servite Court  
Millcroft Road  
Woolon  
Merseyside  
L25 8TS**

| Report Reference: | N-330654 |
| Issue Date: | March 2026 |

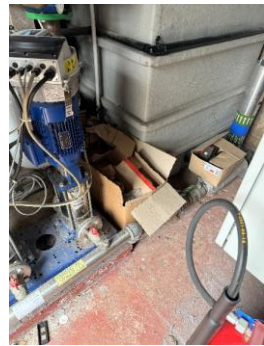
| Significant findings | | |
|---|---|---|
| Item number | 2.5 | |

| Section 2: Sources of Fuel and Oxygen | | | |
|---|---|---|---|
| 2.5 | Is housekeeping to an acceptable standard? | <b>SIGNIFICANT FINDING</b> | <ul style="list-style-type: none"> <li>Housekeeping was generally found to be of a very high standard. Escape routes were clear of combustibles and obstructions.</li> <li><b>Combustible waste items are being stored in the boiler room</b></li> </ul> |

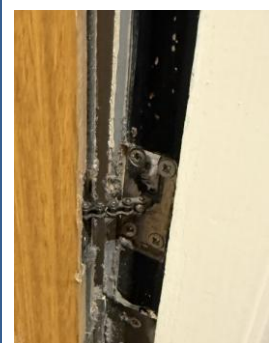
| Section | Comments |
|---|---|
| 4.15 | <p>The Perko-type door closers fitted to the flat front doors appear to be '<b>uncontrolled</b> door closers' and, as such, are no longer acceptable in new buildings under current standards due to unreliability.</p> <p>As they were allowable at the time of construction, it is not deemed reasonably practicable to change them at this time if they are still working effectively.</p> <p>If any devices become defective or do not close the door fully, they should be replaced with a '<b>controlled</b> type' self-closing device, which may be a positive action overhead or concealed door jamb type self-closing device compliant with BS EN 1154.</p> <p>Where a new or replacement self-closing device is fitted, it should not affect the fire resistance of the door when tested in accordance with BS EN1364-1 or BS 476-22</p> |
