**Fire Risk Assessment  
South Liverpool Homes  
2-28 Locke Street  
Garston  
Liverpool  
L19 8EH**

| Report Reference: | N-330652 |
| Issue Date: | March 2026 |

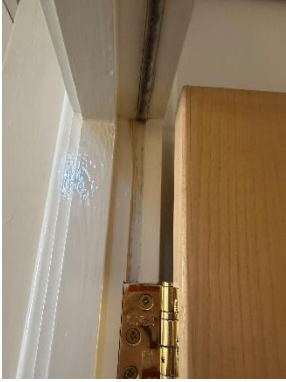
| Task | | |
|---|---|---|
| Significant findings | A small part of intumescent strip and cold smoke seal is missing at the top of a lobby door next to flat 19. | |

| Task | | |
|---|---|---|
| Actions required | Instruct a competent contractor to remediate the door to ensure it meets an FD30 standard. | |

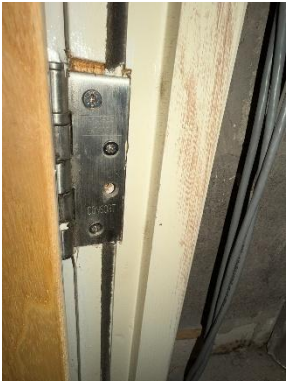
| Task | | |
|---|---|---|
| Significant findings | Screw missing from the hinge of a riser door next to flat 15. | |

| Task | | |
|---|---|---|
| Actions required | Instruct a competent contractor to remediate the door to ensure it meets an FD30 standard. | |

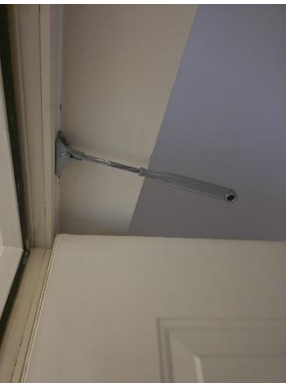
Issue with a flat 9 door with the self-closer broken see action plan.

| Task | | |
|---|---|---|
| Significant findings | The self-closer was broken on the door of flat 9. | |

| Task | | |
|---|---|---|
| Actions required | Instruct a competent contractor to remediate the door to ensure it meets an FD30 standard. | |

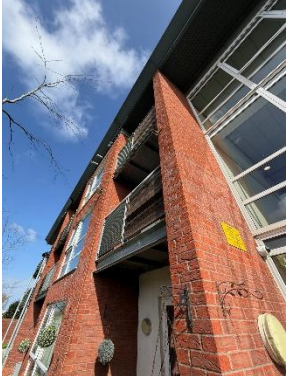
The balcony balustrades are constructed from timber, a separate report has been undertaken for these in 2019. The findings were to implement a management plan and replace the timber with non-combustible material when they get into disrepair. As the timber is in a small section and the floors are steel, the risk of fire spread is very low.

| Significant findings | Small sections of timber used to face the balustrade on the balconies | |

| Actions required | Monitor the timbers and replace with FR material when they deteriorate | |
